**Technical Service
BULLETIN**

**ACCESSORY DRIVE BELT/
BELT TENSIONER ASSEMBLY NOISE**

'00 – '01 Celica & MR2 Spyder

**ENGINE
EG014-01**

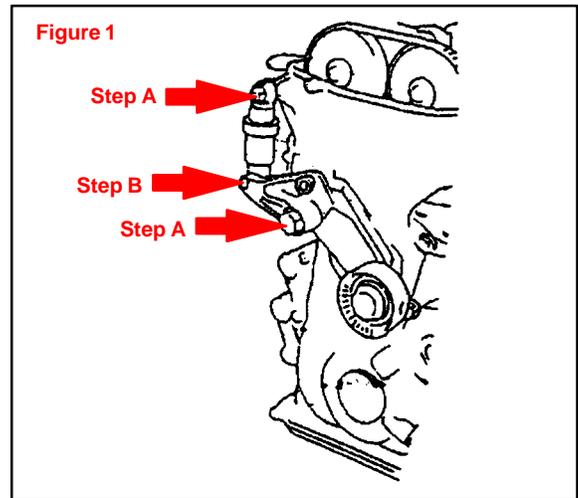
Introduction Some 1ZZ-FE and 2ZZ-GE engines may exhibit squealing and/or rattling noises emanating from the engine compartment during vehicle operation, especially during deceleration at slow speeds after cold soak. The Accessory Drive Belt and Belt Tensioner have been improved to correct this condition.

- A. Remove the Accessory Drive Belt, and then the Tensioner Assembly by removing the fasteners securing the Tensioner Assembly at the pivot point and at the top of the Tensioner Sub-Assembly (see Figure 1).
- B. Place the Tensioner Assembly in a vice and remove the bolt attaching the Tensioner Sub-Assembly to the Tensioner swing arm (see Figure 1).
- C. Remove and replace the Tensioner Sub-Assembly. Replace the bolt securing the Tensioner Sub-Assembly to the idler arm with the new bolt (see Figure 2).
- D. Re-attach the Tensioner Assembly.
