**Technical Service
BULLETIN**

SQUEAK & RATTLE SERVICE TIPS

'00 MR2 Spyder

NVH
NV011-00

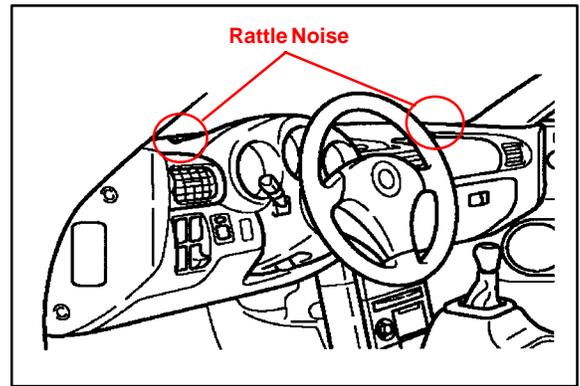
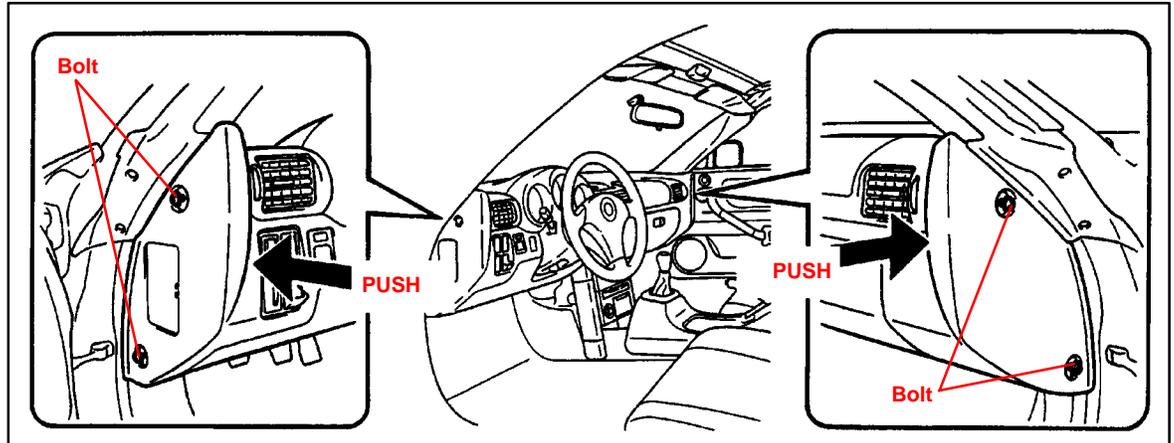
Instrument Panel Rattle Noise

To eliminate a rattle noise from the upper instrument panel area:

1. Loosen the two (2) bolts on each side of the instrument panel.
2. While another technician pushes forward on the instrument panel, retighten the bolts as shown below.

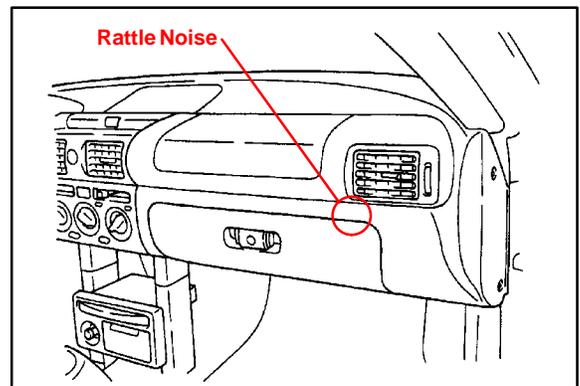
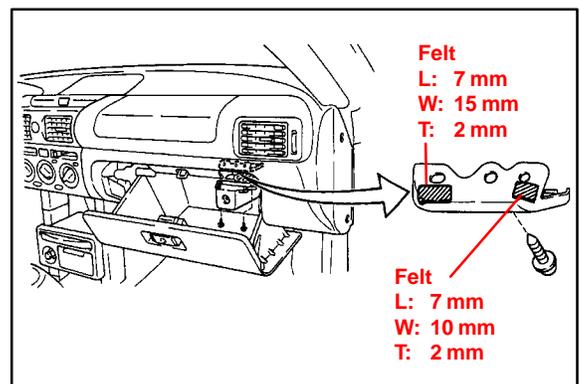
Passenger Airbag Cutoff Switch Rattle Noise

To eliminate a rattle noise from the airbag cutoff switch area:

1. Remove the two (2) bolts that hold the passenger airbag cutoff switch in place.
2. Cut two (2) pieces of felt in the following dimensions:

QTY	L	W	T
1	7 mm	15 mm	2 mm
1	7 mm	10 mm	2 mm

3. Fit felt pieces in the positions shown.
4. Reassemble in the reverse order of disassembly.

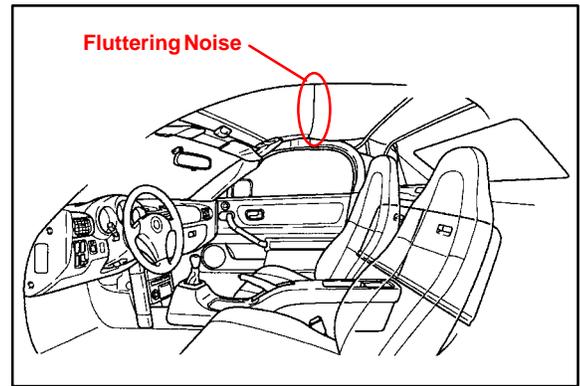
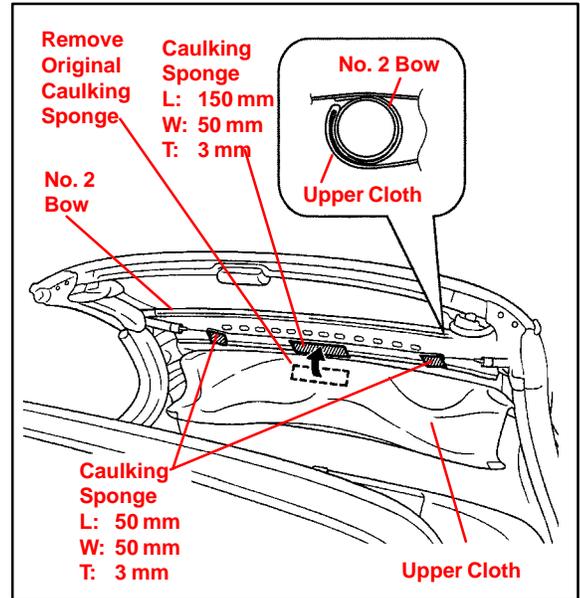
Convertible Top Fluttering Noise

To eliminate a fluttering noise from the convertible top number 2 bow:

1. Remove the convertible top upper cloth (refer to the 2000 MR2 Spyder Repair Manual, pages BO-77 to BO-78).
2. Remove EPT Sealer (caulking sponge) from the center of the inner upper cloth (see illustration).
3. Clean area with Kent® Acrysol (or equivalent).
4. Cut three (3) pieces of EPT Sealer (caulking sponge) in the following dimensions:

QTY	L	W	T
1	150 mm	50 mm	3 mm
2	50 mm	50 mm	3 mm

5. Install EPT Sealer (caulking sponge) in the positions shown.
6. Reassemble in the reverse order of disassembly.

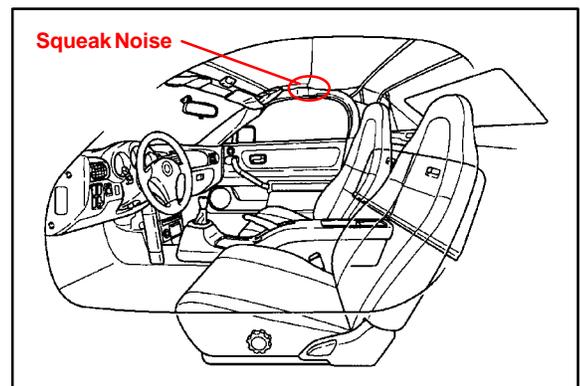
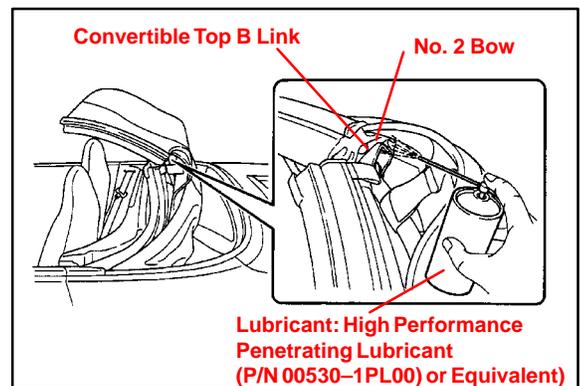
Convertible Top B Link Squeak Noise

To eliminate a squeak noise from the convertible top B link:

1. Open the convertible top to a half-open position.
2. Spray High Performance Penetrating Lubricant (P/N 00530-1PL00) or equivalent in the area shown, being careful to avoid overspray on interior components.
3. Wipe off excess lubricant.

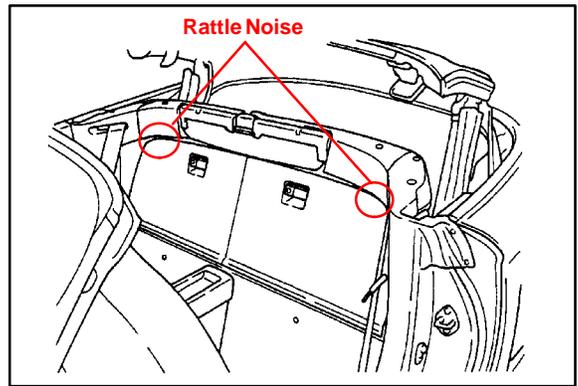
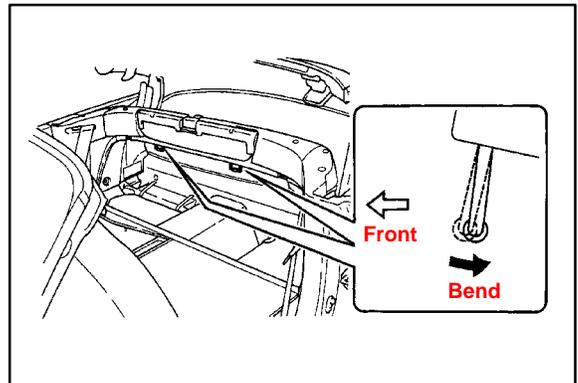
Luggage Compartment Lid Rattle Noise

To eliminate a rattle noise from the luggage compartment lid:

1. Bend the luggage compartment lid striker approximately 3 mm rearward as shown.

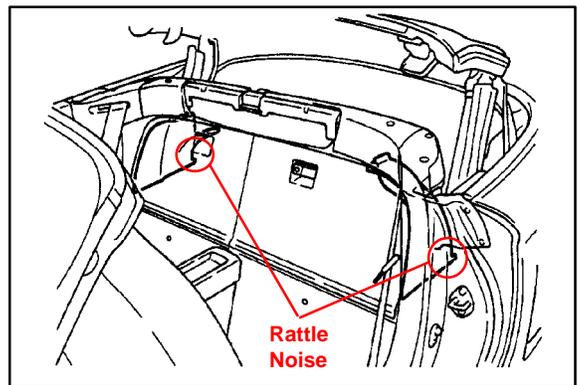
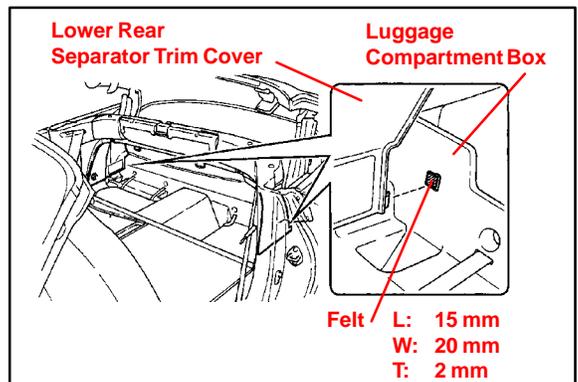
Luggage Compartment Lower Rear Separator Trim Cover Rattle Noise

To eliminate a rattle noise from the luggage compartment lower rear separator trim cover:

1. Cut two (2) pieces of felt in the following dimensions:

QTY	L	W	T
2	15 mm	20 mm	2 mm

2. Install felt in the positions shown.

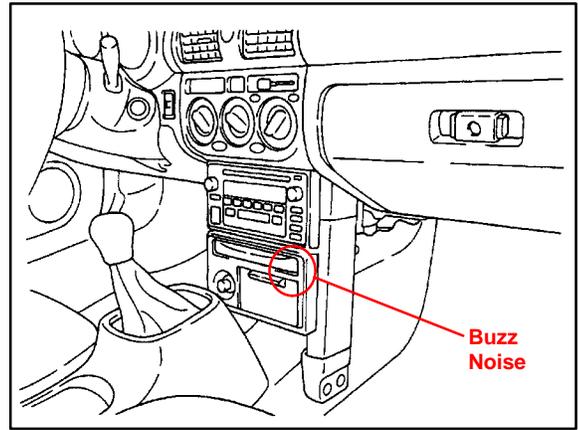
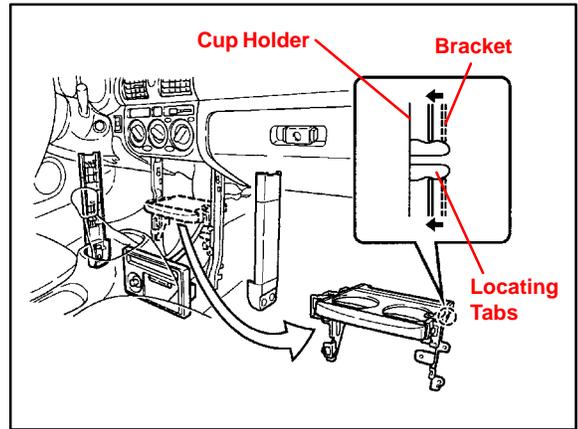
Cup Holder Buzz Noise

To eliminate a buzz noise from the cup holder area:

1. Remove cup holder assembly (refer to the 2000 MR2 Spyder Repair Manual, page BO-42).
2. Reposition cup holder brackets as shown.

NOTE:
It may be necessary to spread the locating tabs slightly for tighter fit.

3. Reassemble in the reverse order of disassembly.

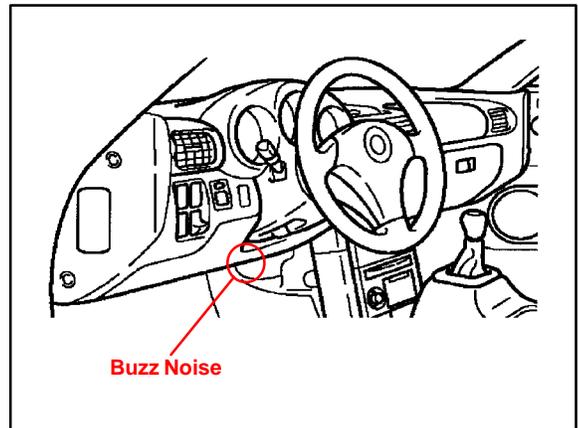
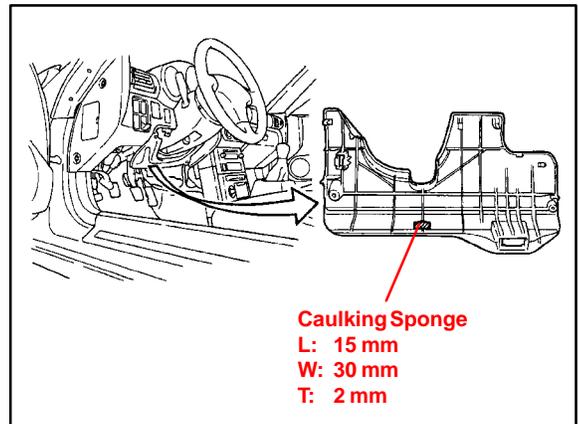
Instrument Panel Lower Finish Panel Buzz Noise

To eliminate a buzz noise from the No. 1 lower finish panel area:

1. Remove the No. 1 lower finish panel.
2. Cut a piece of EPT Sealer (caulking sponge) in the following dimensions:

QTY	L	W	T
1	15 mm	30 mm	2 mm

3. Install EPT Sealer (caulking sponge) in the position shown.
4. Reassemble in the reverse order of disassembly.

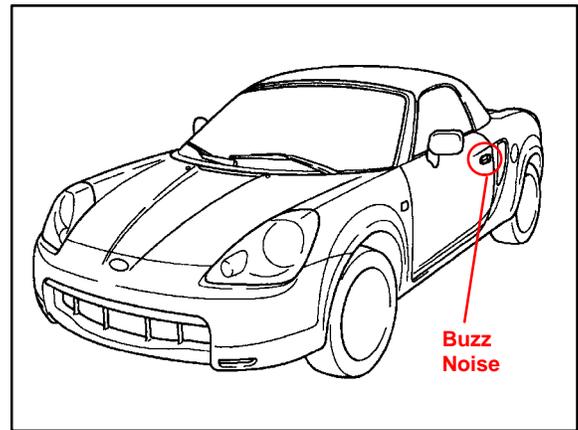
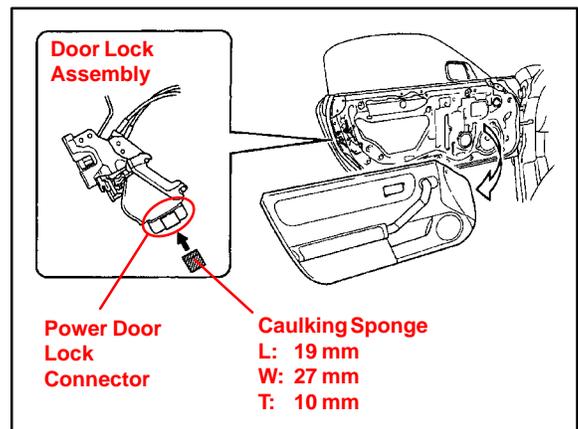
Outside Door Handle Area Buzz Noise

To eliminate a buzz noise near the outside door handle area:

1. Remove the door trim panel (refer to the 2000 MR2 Spyder Repair Manual, pages BO-12 to BO-13).
2. Cut a piece of EPT Sealer (caulking sponge) in the following dimensions:

QTY	L	W	T
1	19 mm	27 mm	10 mm

3. Install EPT Sealer (caulking sponge) on the power door lock connector in the position shown.
4. Reassemble in the reverse order of disassembly.
