SETTING THE SHIFT STROKE OF 3RD - 4TH 'SHIFTER LEVER' or GEAR CHANGE LEVER IN MAZDA P66M MANUAL 6 SPEED TRANSMISSION.

INSTALLED IN NC MIATA MX-5 + 2009-2012 Series II MAZDA RX-8.

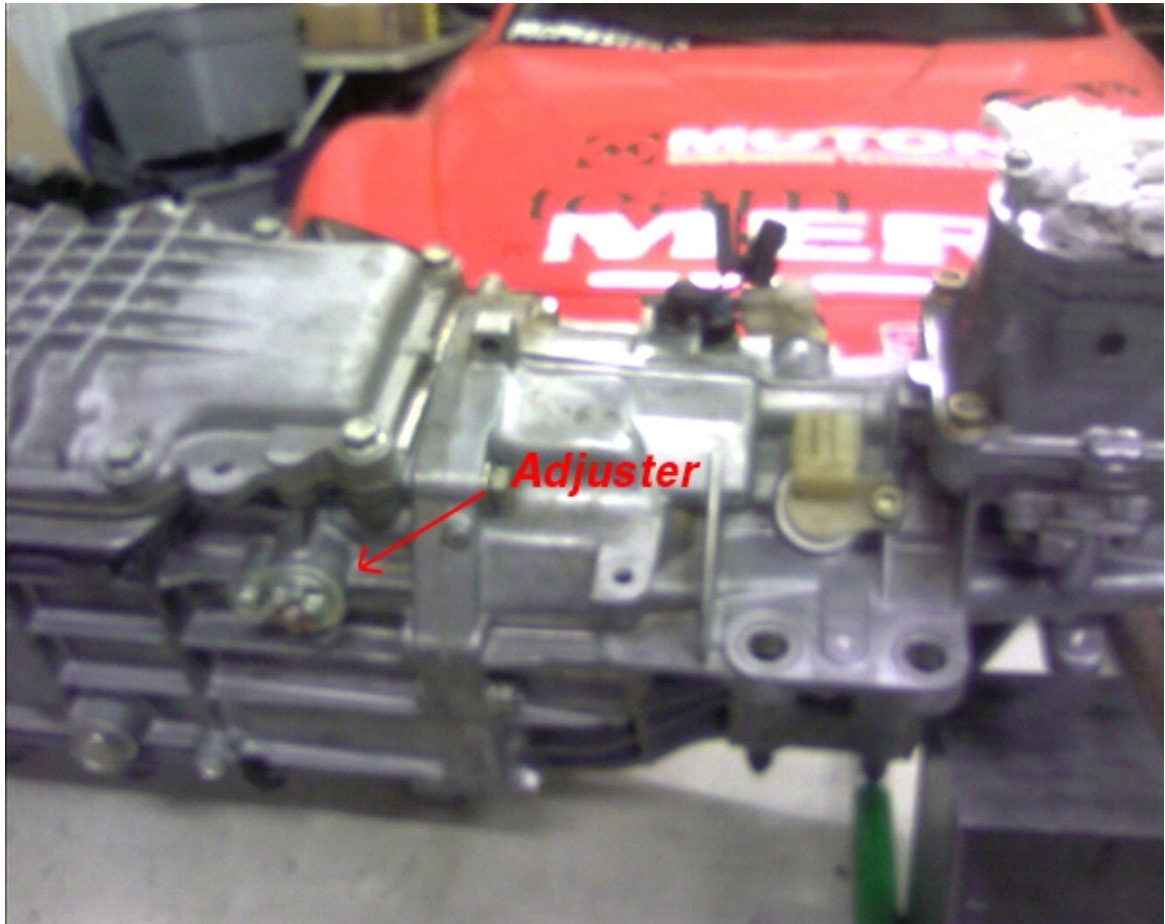
THIS SHOWS THE LOCATION OF THE **COUNTER LEVER SHAFT ADJUSTER** WHICH IS POSITIONED ON THE LEFT SIDE OF OUTER TRANSMISSION CASE.

It's not accessible from the top, you must get under car to adjust. It helps to have the entire car up on stands and to remove the lower cross-member brace to ease access.

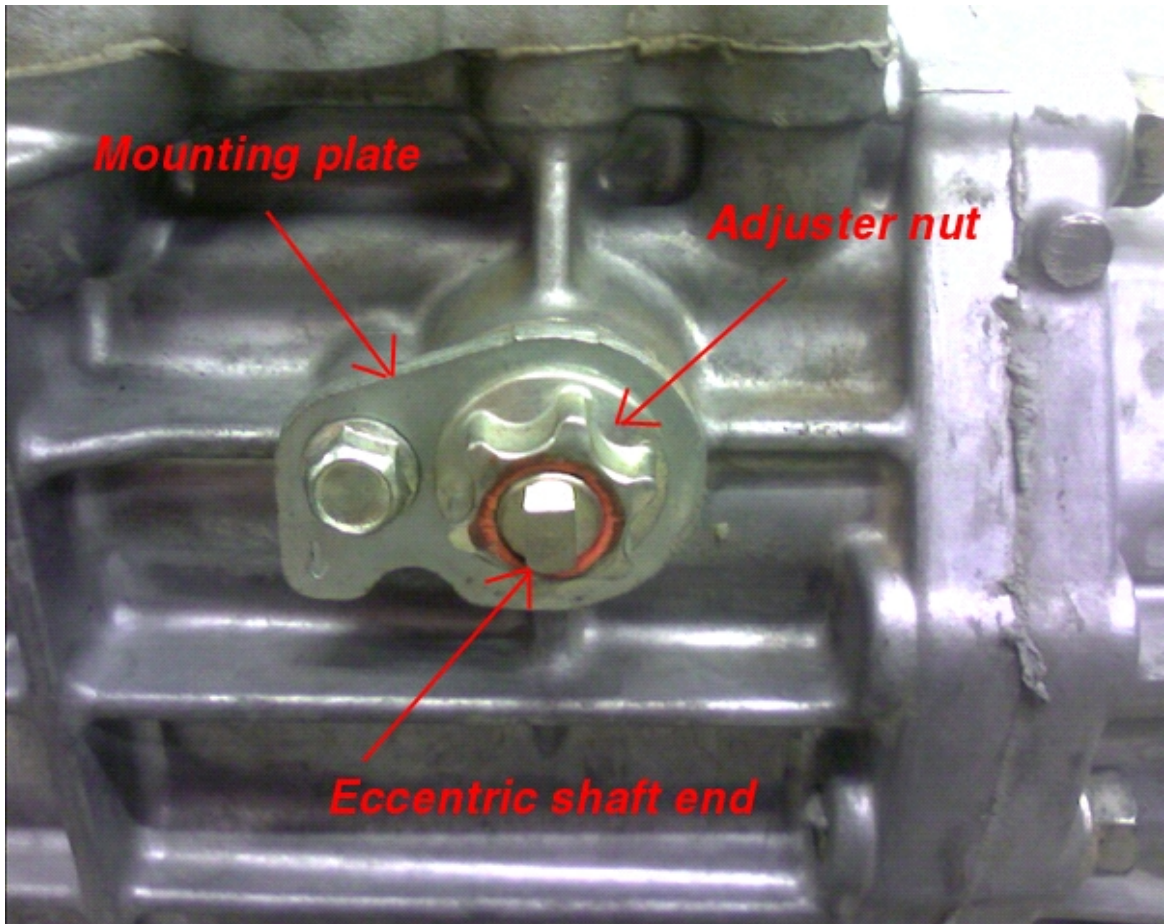
ADJUSTER CLOSE UP.

It's a 19mm 12-pt so you can use a box-end wrench to adjust it.

The eccentric shaft controls the position of the 3rd/4th extension lever that actuates the shift fork. By rotating it, you can change the fore/aft position of the lever versus the shifter mechanism.

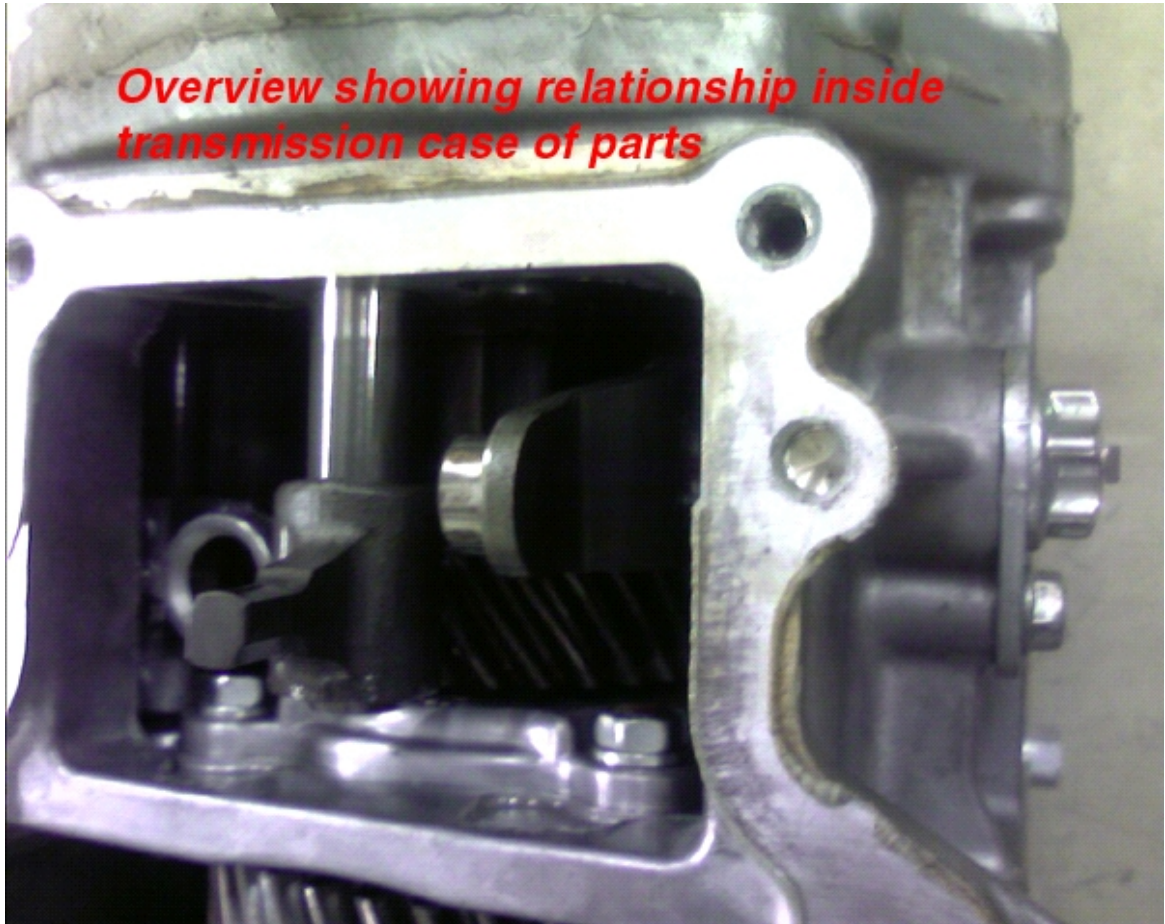
INTERNAL PICTURE OF THE ADJUSTER.

The position of the adjuster in the transmission case with the top cover removed. You can see that the adjuster goes through to the 3rd/4th extension lever.

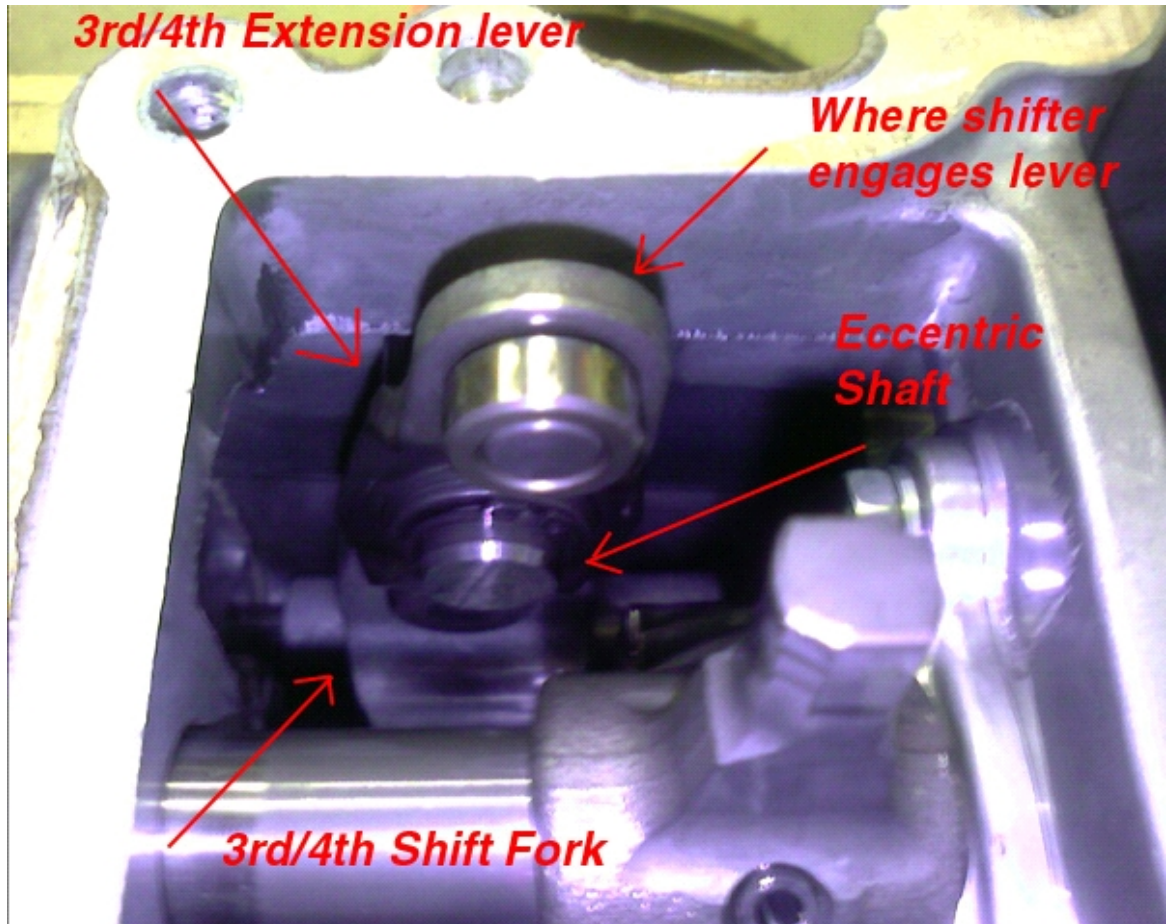
INTERNAL PICTURE OF SAME ADJUSTER.

Shows another position of the eccentric shaft, the 3rd/4th extension lever, and the actual shift fork (see below).

The 3rd/4th gears are on the counter-shaft in this transmission to make room for all the six gears, the extension lever is necessary to get the shift-motion down to the lower part of the case where these gears actually reside.

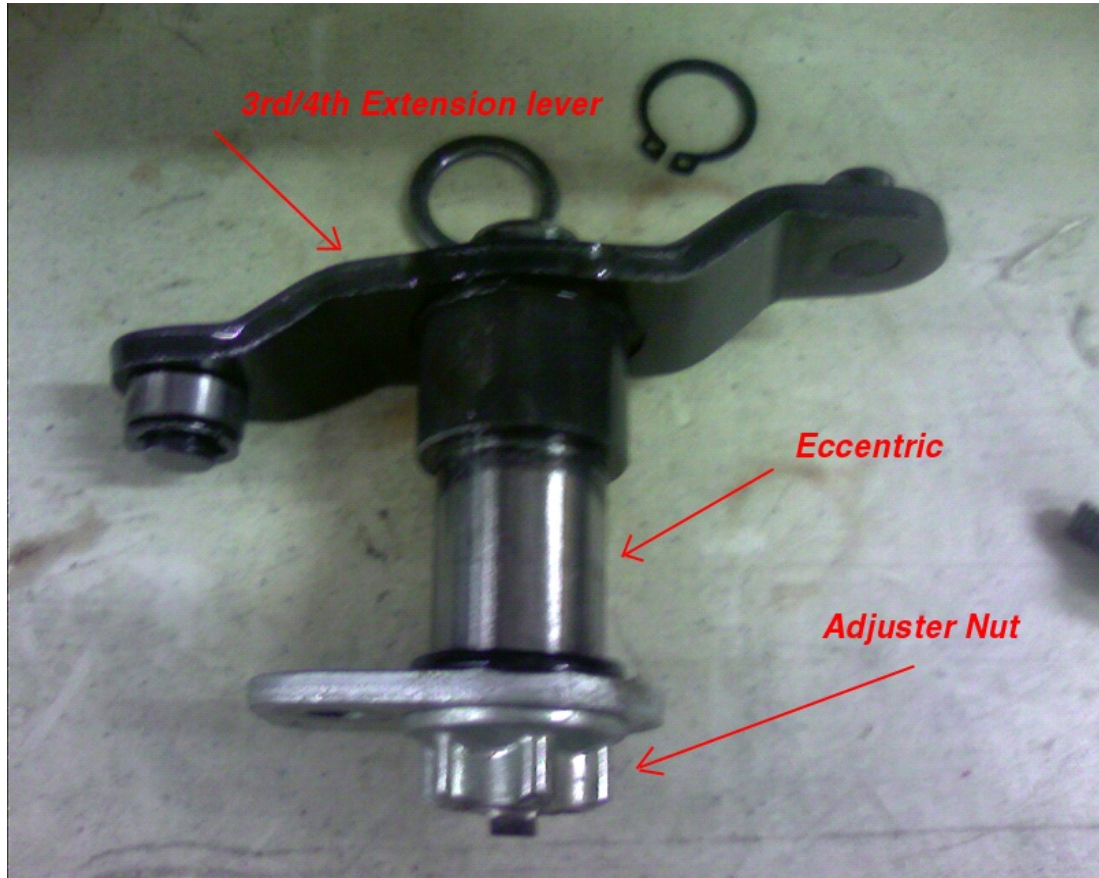
COUNTER LEVER SHAFT ADJUSTER AND 3/4 EXTENSION LEVER REMOVED.

As you can see, there is an o-ring to seal, and you can see where the eccentric portion of the shaft rides in a bore in the trans case.

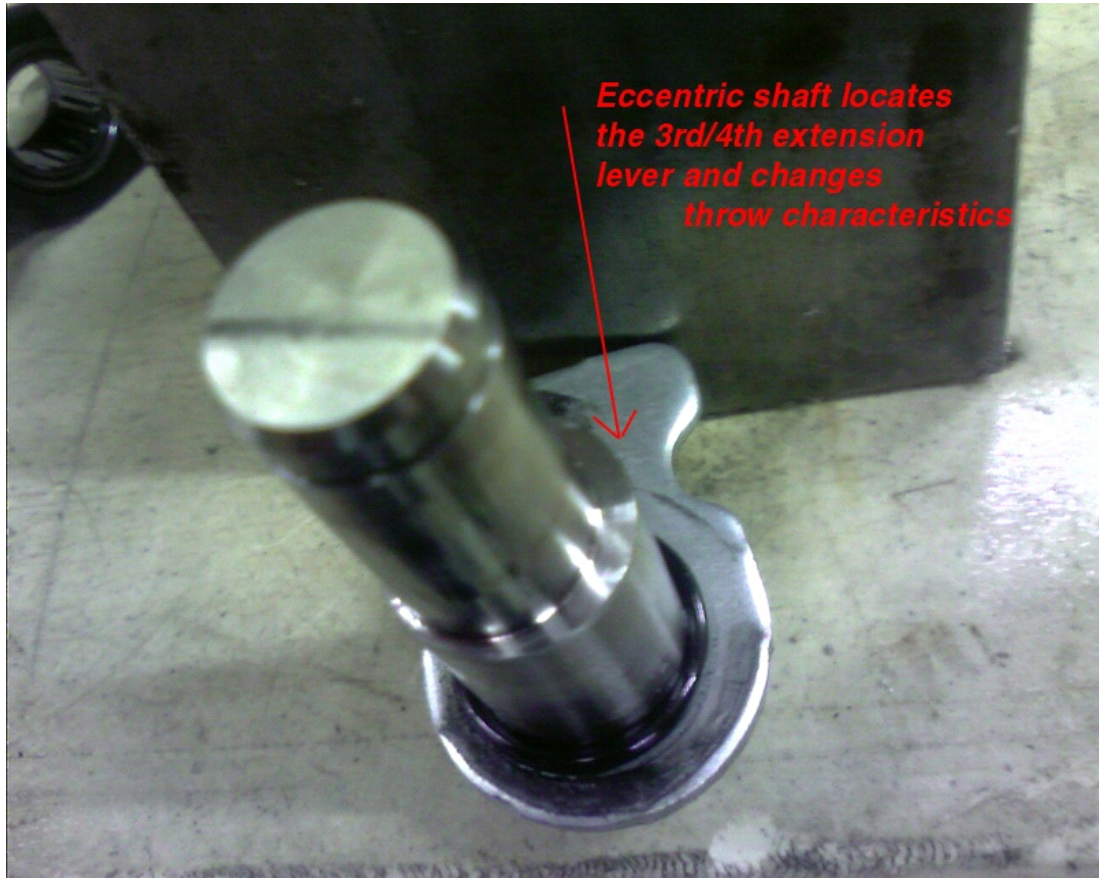
ECCENTRIC SHAFT.

The eccentric shaft lobe portion of the shaft.

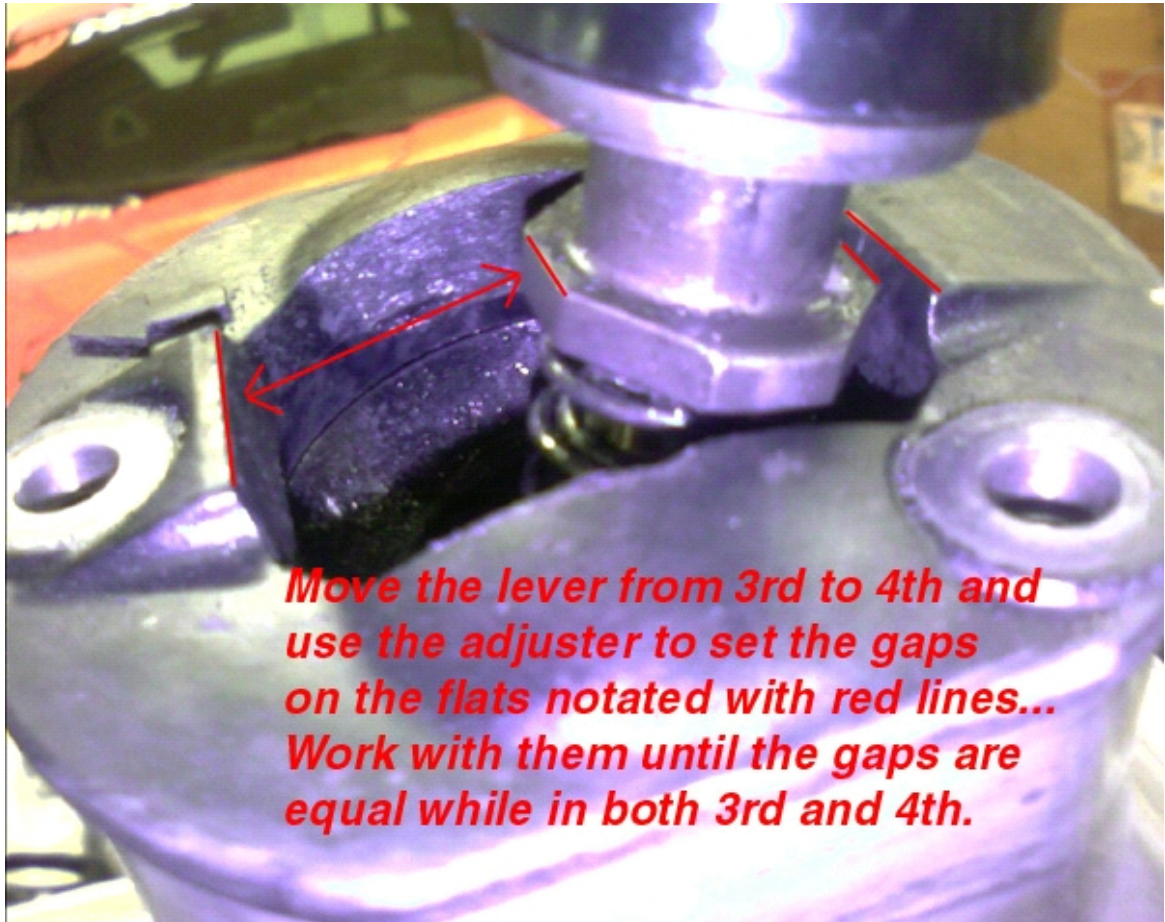
Where the red lines are in the picture are the gaps in question.

The flats will touch when the adjustment is right, and there will be a gap when it is wrong.

Basically (it helps if you have two people,) you move the adjuster nut back and forth until you equalize the gaps on the flats pictured...**extremely important to be accurate.**

You go back and forth between 3rd and 4th and you check in each gear.

You are finished when you have equalized the gaps front and rear.

The best way to do this is to 'hold' the shifter forward or back and have a helper move the adjuster.

Once the adjuster is correctly positioned, you can mark it with a sharpie or paint pen and then visually check adjuster and lock nut from time to time.

Chamfer side of e-shaft should point straight upward.

Apply Sealant to the threads of star lock nut.

37.3—51.9 N·m {3.81—5.29 kgf·m, 27.6—38.2 ft·lbf}

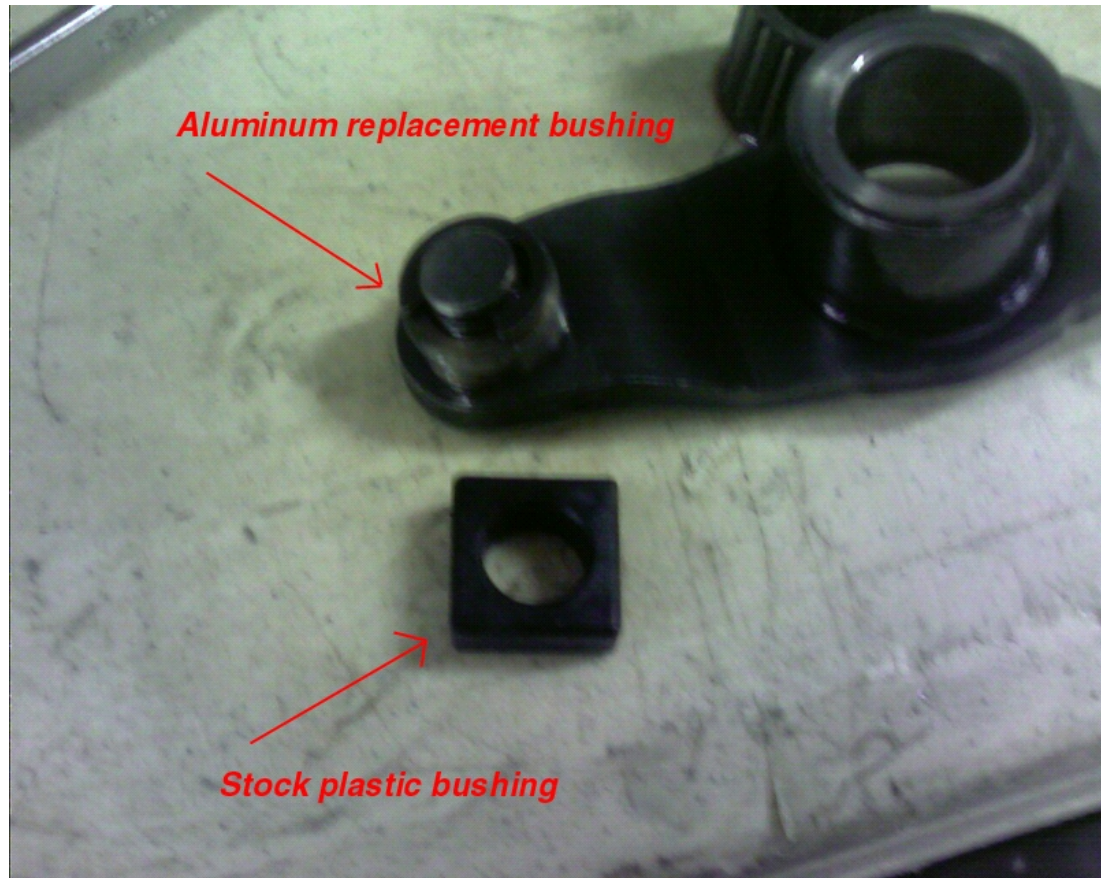
3/4 LEVER BUSHING.

Many racers renew the OEM stock installed square plastic bushings with either a round aluminum or locally fabricated brass square bush as the hard plastic bush tends to crush wear under extreme track conditions.

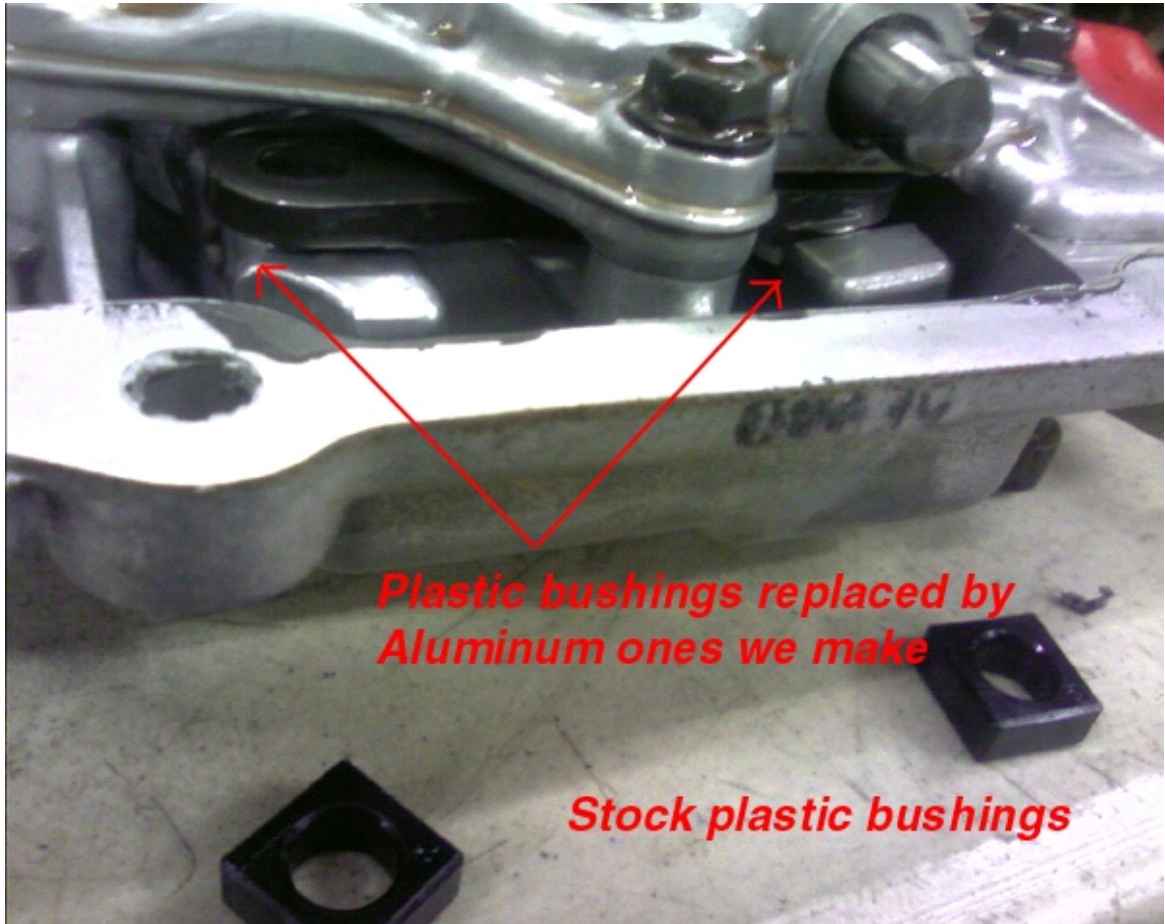
OEM BUSH REPLACEMENT WITH LOCAL FABRICATED ONES.

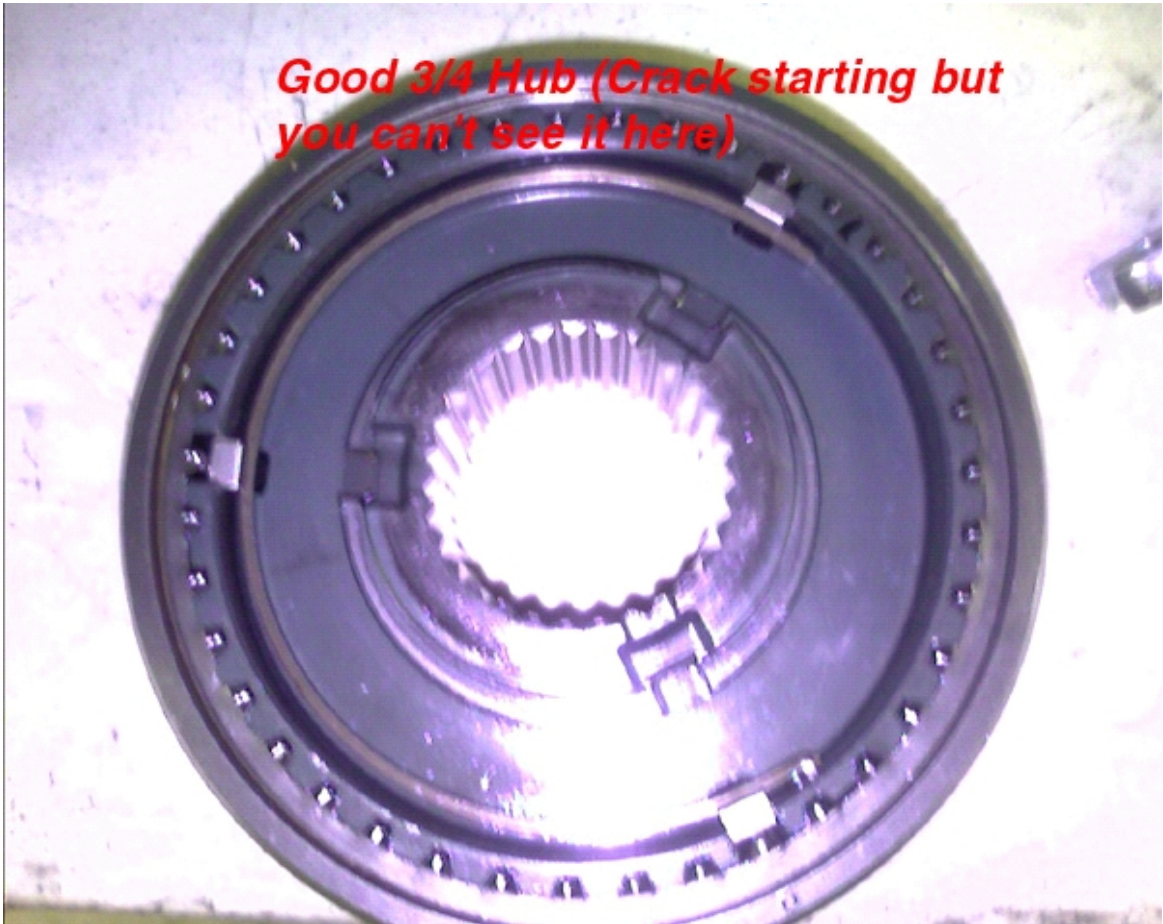
3/4 SHIFT HUB PICTURE.

This is a normal 3rd/4th shift hub which were know to give problems (cracking) on some early P66M Miata Transmissions. These Hubs have since been upgraded from February 2008 production.

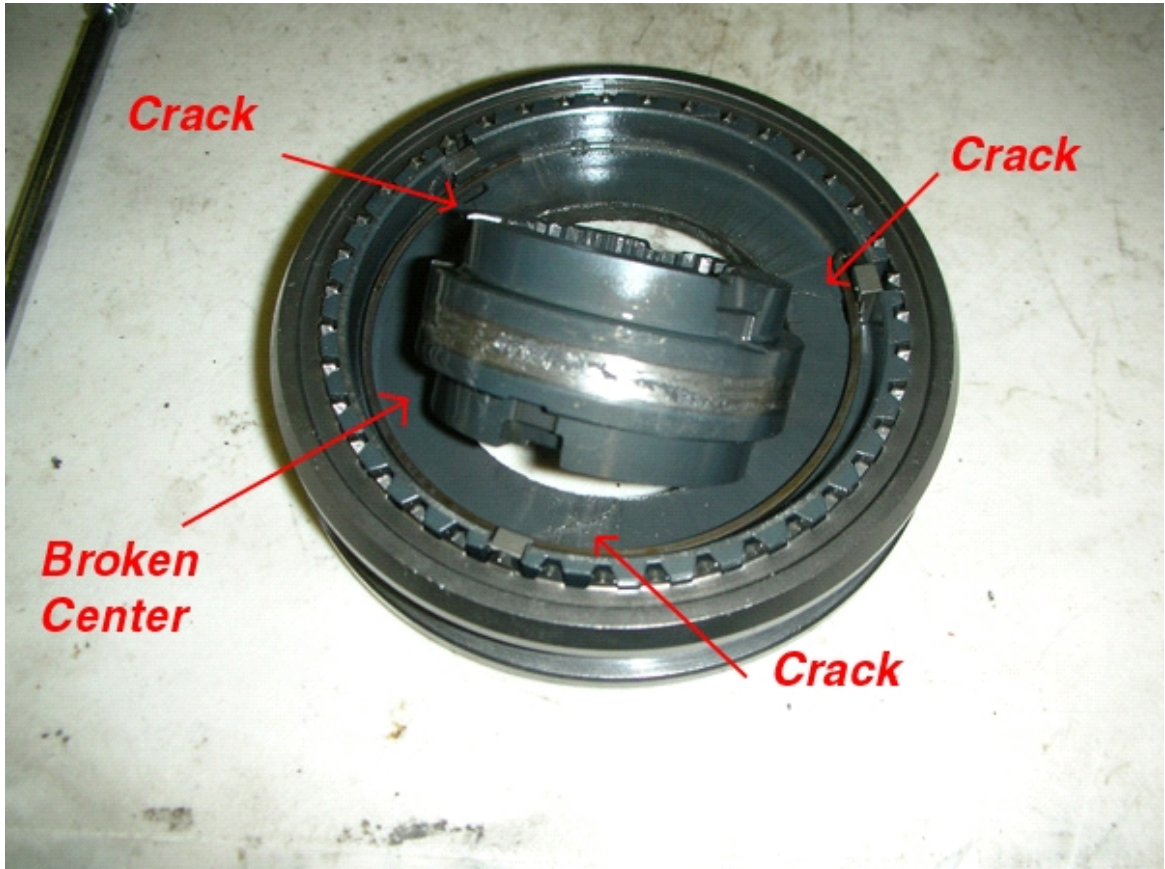
DAMAGED 3/4 HUB SET.

Remember this picture is taken from a racing P66M Miata Transmission. A normal domestic Miata/MX-5 should not normally see this type of wear damage.

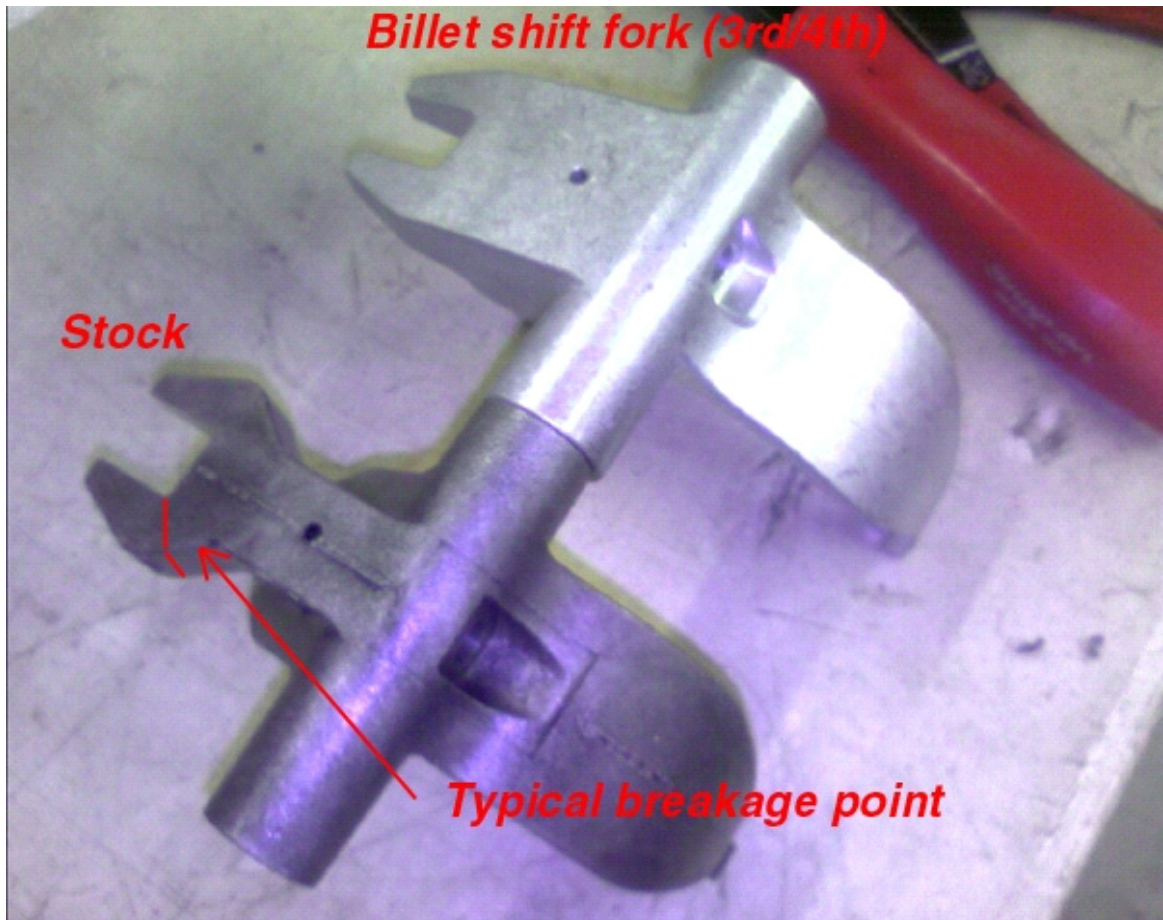
SHIFT FORKS HAS ALSO BEEN UPGRADED FROM February, 2008.

It is also worth noting that Mazda further upgraded the P66M Transmission for the Series II RX-8 with some heavier duty components to address the few shortcomings with the original NC1 MX-5 Miata P66M.
