Subject: UNSTABLE IDLING/ENGINE STALLS JUST AFTER STOPPING	Bulletin No: 01-007/09
	Last Issued: 02/11/2009

APPLICABLE MODEL(S)/VINS

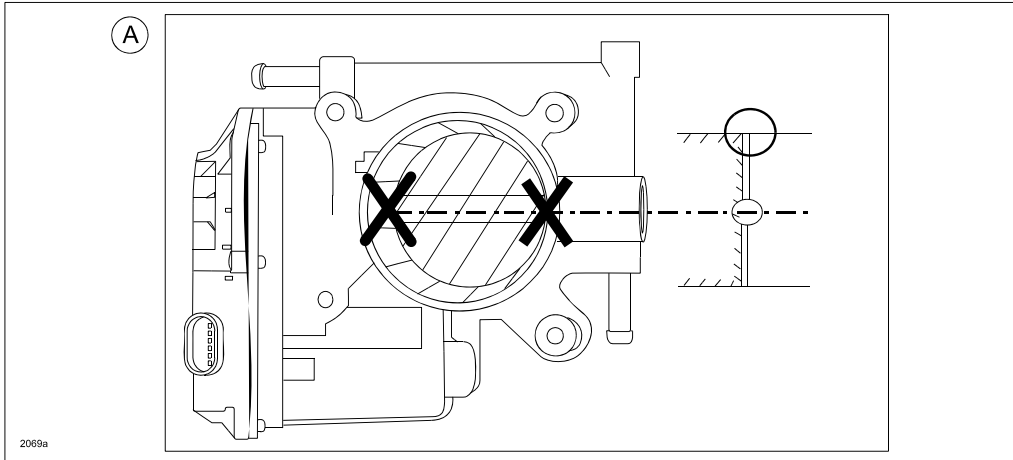
Some vehicles may exhibit a concern of unstable idling or, in some rare cases, stalling, just after the vehicle stops with no DTCs detected. The problem is due to the accumulation of carbon deposits inside the throttle body causing air flow to decrease.

CAUTION: DO NOT spray the cleaner directly inside the throttle body and DO NOT wipe around the throttle valve shaft shown with an X.

3. Clean the throttle body.
 - a. Clean the inside throttle body on the air hose side using a clean and soft shop cloth sprayed with engine cleaner (part number 000-77-A86) along the cross hatch areas, and especially around the circled areas as shown.

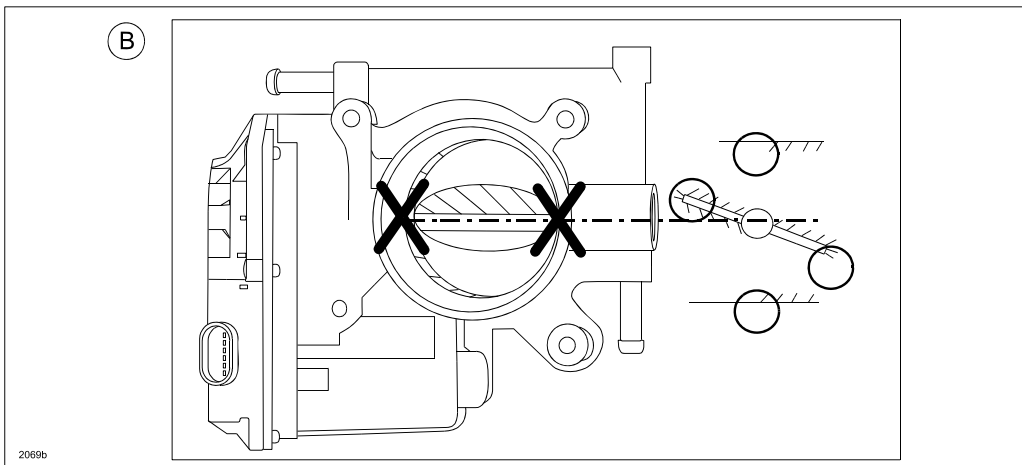
CAUTION: DO NOT spray the cleaner directly inside the throttle body and DO NOT wipe around the throttle valve shaft shown with an X.

- b. Turn the throttle body to clean it at the intake manifold side.
 - c. Clean the throttle with the throttle valve opened using the same shop cloth and cleaner.

WARNING: Be careful not to pinch your fingers in the throttle valve when it is opened because the valve will close automatically from spring tension.
