<b>Subject:</b>  CLUNK NOISE FROM DRIVE SHAFT	<b>Bulletin No:</b> 03-002/10
	<b>Last Issued:</b> 07/07/2010

## BULLETIN NOTE

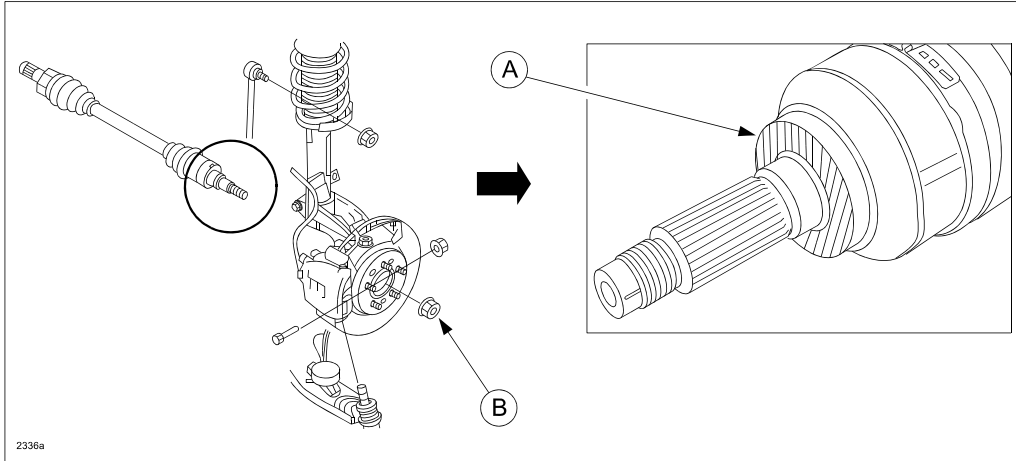
Some vehicles may exhibit a clunk noise from the front drive shaft or the rear drive shaft when moving forward/backward from a stop. This is caused by a stick-slip noise due to excessive force created between the drive shaft and the wheel bearing. Grease is now applied between the drive shaft and the wheel bearing to correct this.

3. Clean the drive shaft and the wheel bearing mating surface (A).

**NOTE:** Replace the nut (B) with a new one.
