<b>Subject:</b> <b>POWER RETRACTABLE HARDTOP - FRONT ROOF PANEL CONTACTS DECK PANEL</b>	<b>Bulletin No:</b> 09-035/07
	<b>Last Issued:</b> 10/1/2007

2007 MX-5 vehicles with VINs lower than JM1 NC\*\*\*\* \*\* 132933 (built before December 11, 2006)

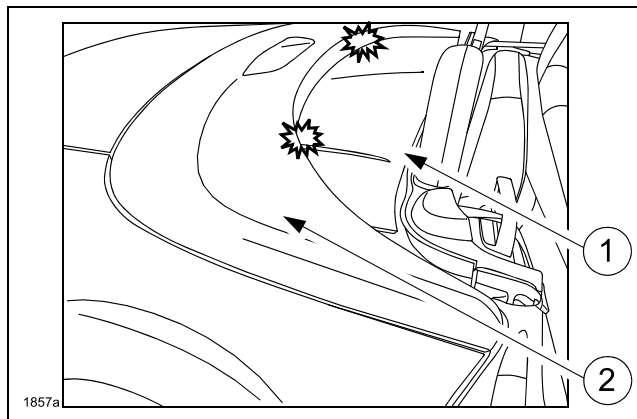
On some power retractable hard top vehicles, the front panel (1) of the hard top may contact with the deck panel (2) when in the open position. This condition may be the result of improper engagement of the roof hook, due to the roof hook cable coming loose from the cable case.

Inspect the roof hook cable for disengagement from the cable case; this case is located behind the access panel, behind the driver's seat. If it is found to be disengaged, replaced the cable case using the following procedures.
