Service Information

Category U	Repair Guidance	Ref. No. R085/15A	Page 1 of 2
Coverage <input type="checkbox"/> Distributor only <input checked="" type="checkbox"/> Please inform your dealers		Date Issued September 16, 2015	
Please convey this information to your <input type="checkbox"/> Director <input checked="" type="checkbox"/> General Manager <input checked="" type="checkbox"/> Warranty Dept. <input checked="" type="checkbox"/> Parts Dept. <input checked="" type="checkbox"/> Training Dept. <input checked="" type="checkbox"/> Field Rep.		Date Revised November 20, 2015	
Applicable Model MX-5 (ND)		Applicable Countries or Specifications Worldwide

Subject: Poor A/C performance

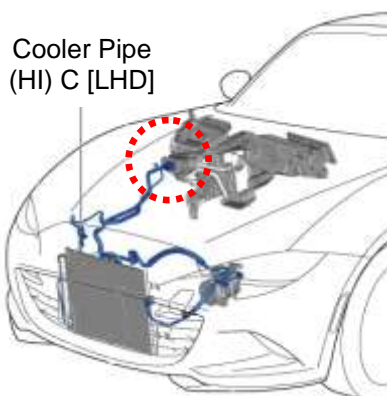
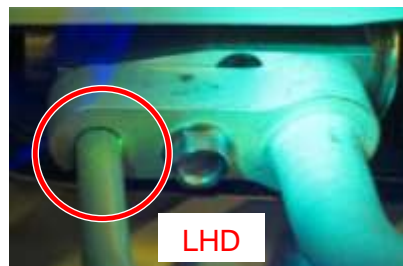
Due to the tolerance of the O-ring groove on the cooler pipe (high pressure side) at the expansion valve, it may cause slow leakage of the refrigerant.

Leakage at Expansion Valve

Using a refrigerant leak detector or a black light, determine the leakage. If it leaks at the connection where the "Cooler Pipe (HI) C" connects to the expansion valve, replace the "Cooler Pipe (HI) C" with a new one according to the Workshop Manual "REFRIGERANT LINE REMOVAL/INSTALLATION".

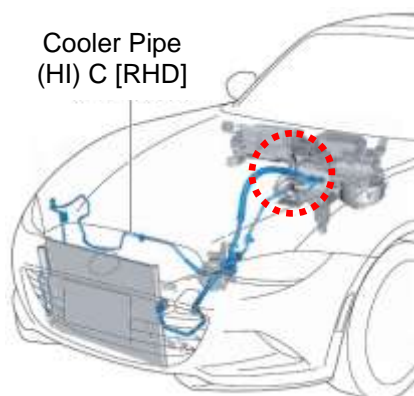
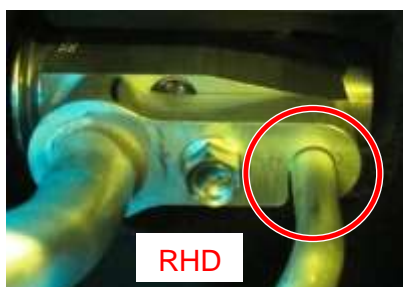
Leakage at Expansion Valve
