Service Information

Category S	Repair Guidance	Ref. No. R026/17	Page 1 of 3
Coverage <input type="checkbox"/> Distributor only <input checked="" type="checkbox"/> Please inform your dealers		Date Issued April 13, 2017	
Please convey this information to your <input type="checkbox"/> Director <input checked="" type="checkbox"/> General Manager <input checked="" type="checkbox"/> Warranty Dept. <input checked="" type="checkbox"/> Parts Dept. <input checked="" type="checkbox"/> Training Dept. <input checked="" type="checkbox"/> Field Rep.		Date Revised	
Applicable Model MX-5 (ND)	Applicable Countries and/or Vehicle Specifications Worldwide

Subject: Corrosion on Front Door Quarter Glass Guide at where it contacts Beltline Molding

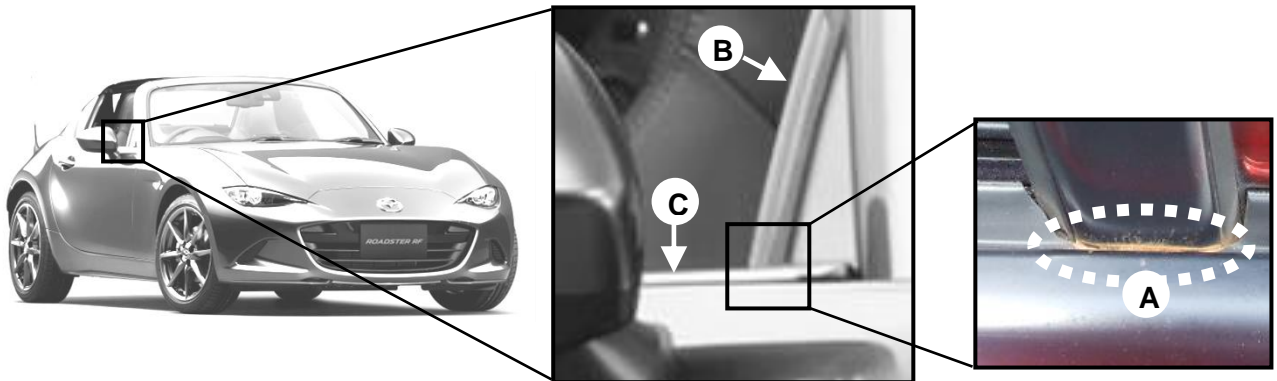
Some vehicles may exhibit Corrosion (A) on the front door quarter glass guide (B) at the point where it contacts the door beltline molding (C).

This concern is caused by the beltline molding contacting the quarter glass guide due to production variances. The paint on the quarter glass guide then gets damaged by vibration during the door closing and the vehicle driving.

A spacer has been attached to the concerned area of beltline molding to assure an appropriate clearance between the beltline molding and the quarter glass guide.
