## SIDE PANEL NO.4 REINFORCEMENT (ASSY) REPLACEMENT

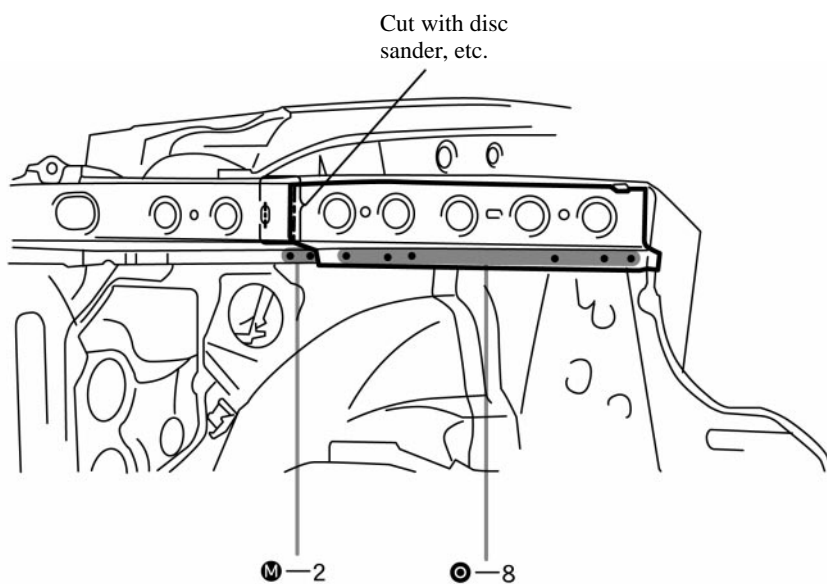
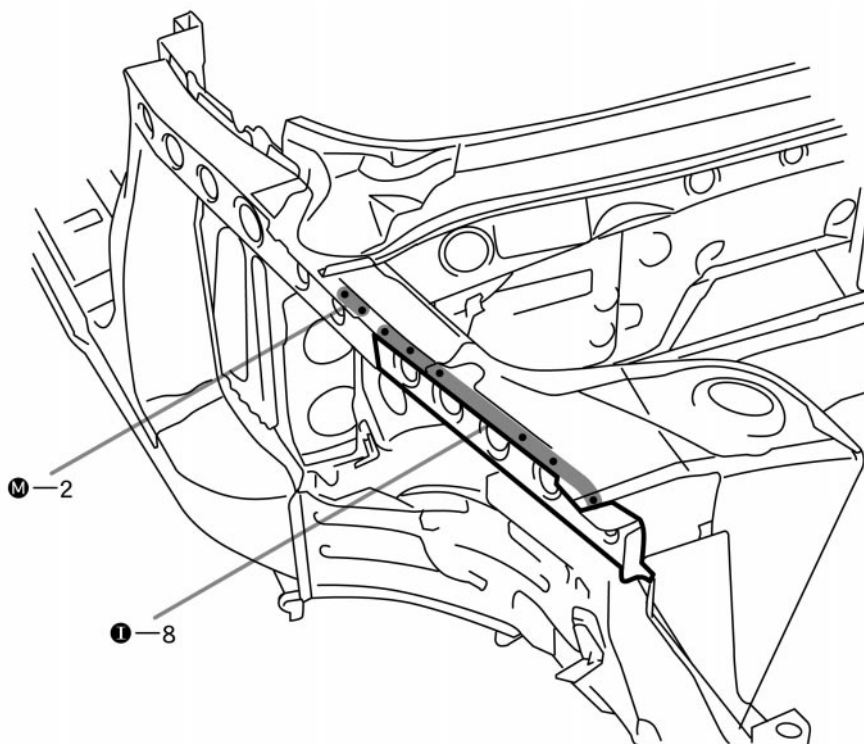
1. REMOVE FRAME REAR UPPER CROSSMEMBER (See page BP-62)
2. REMOVE SIDE PANEL NO.4 REINFORCEMENT

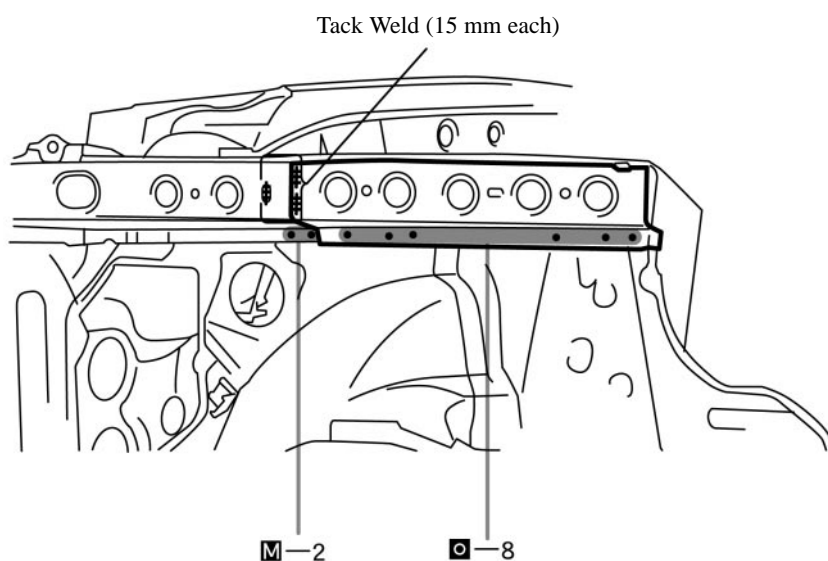
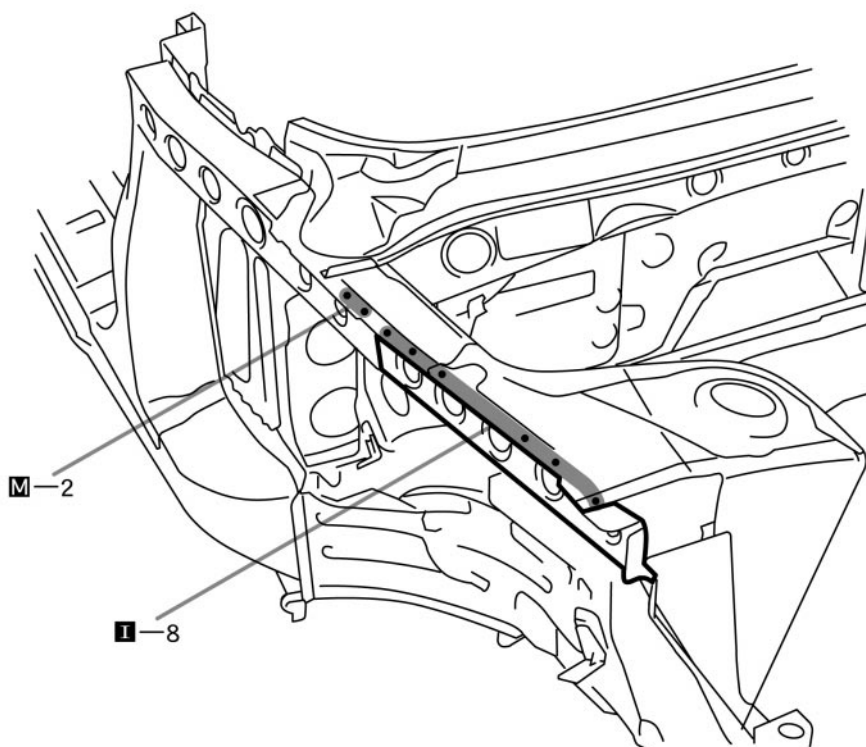
**3. INSTALL SIDE PANEL NO.4 REINFORCEMENT**

mm	in.
15	0.59

- 
4. **INSTALL FRAME REAR UPPER CROSSMEMBER (See page BP-63)**
  5. **APPLYING SEALER TO THE ENGINE COMPARTMENT (See page PC-1)**
  6. **APPLYING ANTI-RUST AGENT**
    - (a) After applying the top coat layer, apply the anti-rust agent to the inside of the necked section structural weld spots.
