Service Information

Category T	Repair Guidance	Ref. No. R018/18	Page 1 of 3
Coverage <input type="checkbox"/> Distributor only <input checked="" type="checkbox"/> Please inform your dealers		Date Issued March 20, 2018	
Please convey this information to your <input type="checkbox"/> Director <input checked="" type="checkbox"/> General Manager <input checked="" type="checkbox"/> Warranty Dept. <input checked="" type="checkbox"/> Parts Dept. <input checked="" type="checkbox"/> Training Dept. <input checked="" type="checkbox"/> Field Rep.		Date Revised	
Applicable Model Mazda2(DJ) , CX-3 (DK) and MX-5(ND)		Applicable Countries and/or Vehicle Specifications Worldwide

Subject: Spider cracking on Center Display

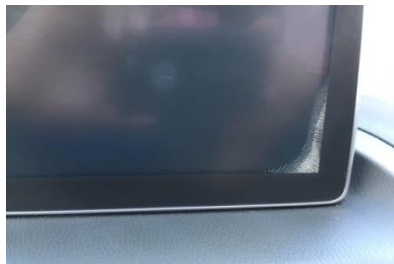
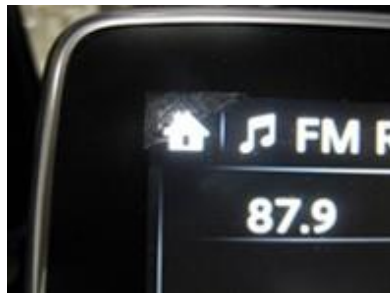
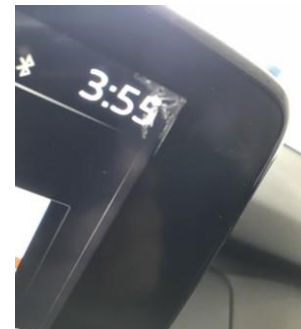
Some customers may complain about poor appearance (Spider cracking) on the center display. Since it is internal damage of the display, there is no dent or crack on the surface.

Insufficient glue between the touch screen layers.

Manufacturing process has been changed.

1. Check if the screen is internally damaged (no external impact).
IF YES, go to the next step.
IF NO, this Service Information does not apply.
2. Replace the center display with a modified one according to the workshop manual.
See the workshop manual "CENTER DISPLAY REMOVAL/INSTALLATION".
3. See the label at the bottom of the center display to check if production date is in or after July 7/2016.
IF YES, this Service Information does not apply. Submit a warranty claim according to the normal warranty procedure.
IF NO, submit a warranty claim according to the warranty information of this Service Information.

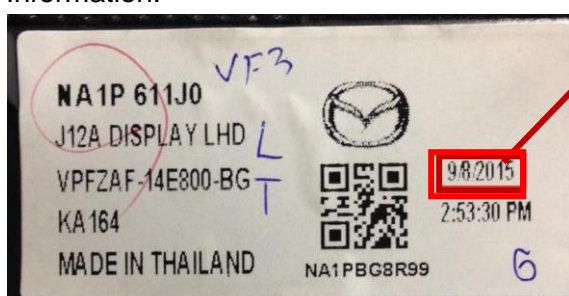
Month/Date/Year.
