2008 ELECTRICAL Charging System - MX-5 Miata

Charging System - MX-5 Miata

CHARGING SYSTEM LOCATION INDEX [LF]

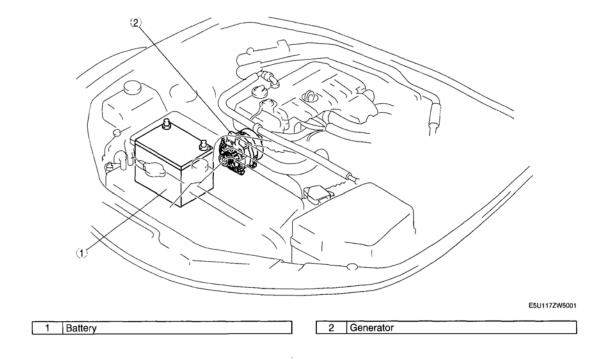
Fig. 1: Identifying Location Of Charging System Components Courtesy of MAZDA MOTORS CORP.

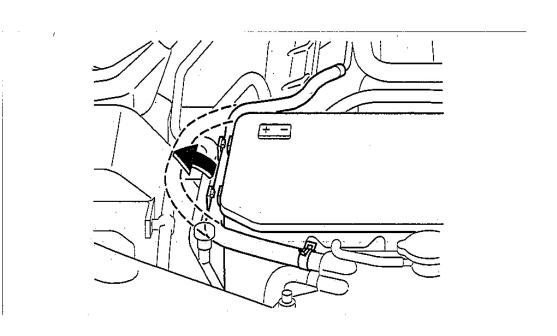
1. Remove the rubber hose from the battery cover.

Fig. 3: View Of Rubber Hose Courtesy of MAZDA MOTORS CORP.

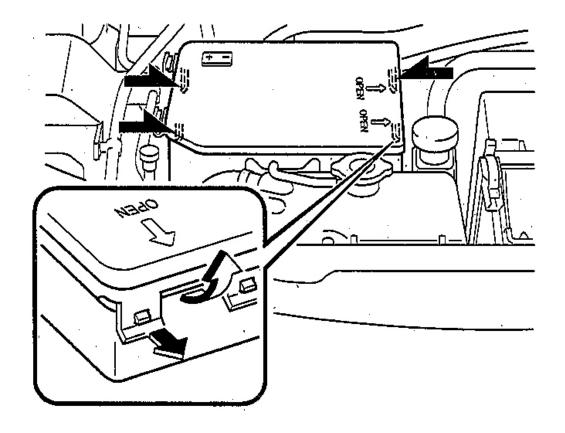
2. Remove the battery cover from its right side.

Fig. 4: View Of Right Side Battery Cover Courtesy of MAZDA MOTORS CORP.

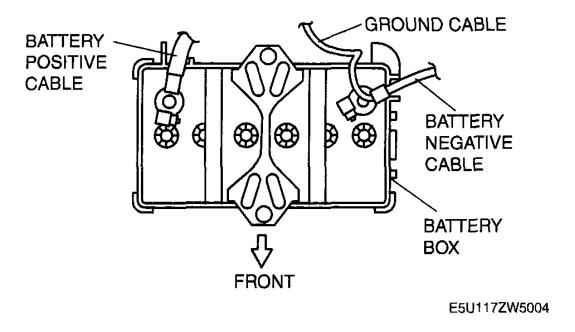
Fig. 5: Connecting Negative Battery Cable Courtesy of MAZDA MOTORS CORP.

1. When connecting the negative battery cable to the battery, connect the negative battery cable and the ground cable as shown in **Fig. 5**.

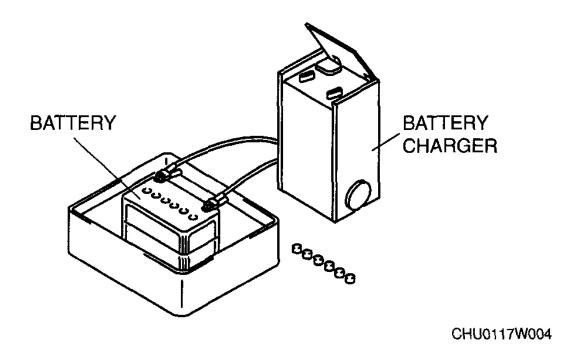
- Do not quick charge for more than 30 min. It will damage the battery.
- 1. Remove the battery and then place it in a pan of water.
- 2. Connect a battery charger to the battery and adjust the charging current as follows.

46B24L (36): 3.5-4.5 A

46B24L (36): 25 A

Fig. 6: Connecting Battery Charger To Battery Courtesy of MAZDA MOTORS CORP.

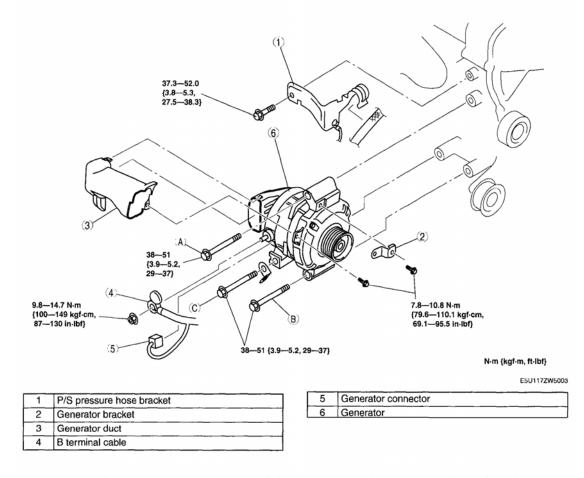
- 1. Remove the battery and battery tray. (See **BATTERY REMOVAL/INSTALLATION [LF]** .)
- 2. Remove the drive belt. (See **DRIVE BELT REPLACEMENT [LF]**.)
- 3. Remove in the order indicated in the table.
- 4. Install in the reverse order of removal.

Fig. 7: Identifying Removal Order Of Generator (With Torque Specifications) Courtesy of MAZDA MOTORS CORP.

- 1. Tighten bolt A temporarily.
- 2. Tighten bolt B, C to the specified tightening torque.
- 3. Tighten bolt A to the specified tightening torque.

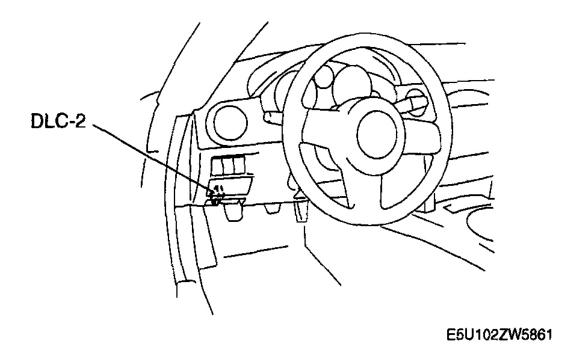
1. Connect the M-MDS or equivalent to the DLC-2.

Fig. 9: Locating DLC-2 Connector Courtesy of MAZDA MOTORS CORP.

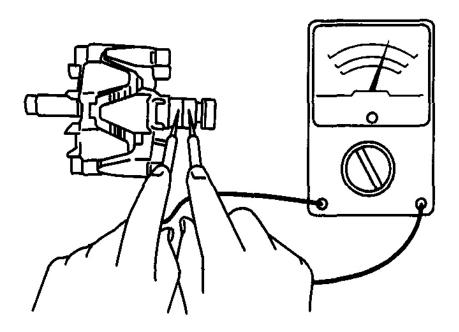
CHU0117W005

- 1. Measure the resistance between the slip rings using a tester.
 - If not within the specification, replace the rotor.

2.0-2.3 ohm

Fig. 10: Measuring Resistance Between Slip Rings Using Tester Courtesy of MAZDA MOTORS CORP.

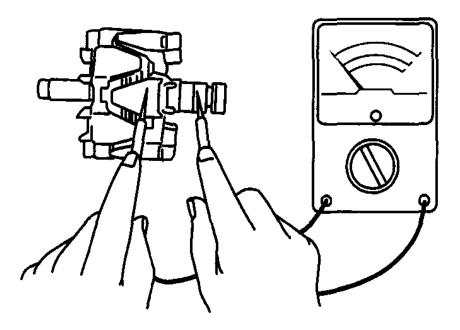
CHU0117W006

- 2. Verify that there is no continuity between the slip ring and core using a tester.
 - If there is continuity, replace the rotor.

Fig. 11: Verifying There Is No Continuity Between Slip Ring & Core Courtesy of MAZDA MOTORS CORP.

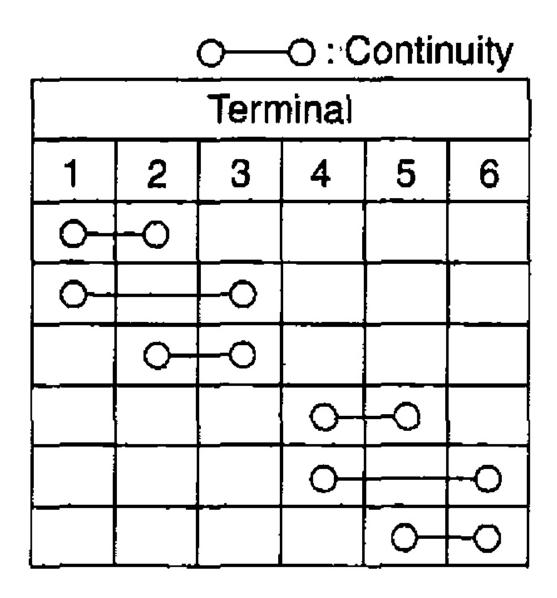
Fig. 12: Stator Coil Terminal Continuity Check Table Courtesy of MAZDA MOTORS CORP.

1. Verify that the continuity is as indicated in Fig. 12.

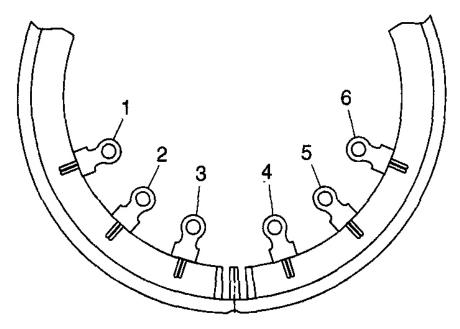
E6U117ZWB005

Fig. 13: Identifying Stator Coil Terminals Courtesy of MAZDA MOTORS CORP.

- If there is any malfunction, replace the stator.
- 2. Verify that there is no continuity between the stator coil leads and core using a tester.
 - If there is continuity, replace the stator coil.

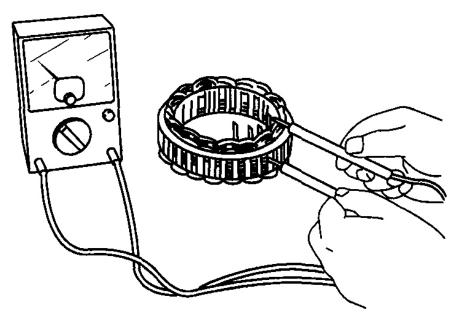
CHU0117W008

Fig. 14: Inspecting Continuity Between Stator Coil Leads And Core Courtesy of MAZDA MOTORS CORP.

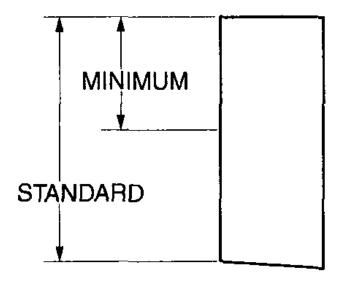
E5U117ZW5005

- 1. Inspect brushes for wear.
 - If any brush is worn almost to or beyond the limit, replace all of the brushes.

Minimum: 5.0 mm {0.20 in}

Fig. 15: Inspecting Brushes For Wear Courtesy of MAZDA MOTORS CORP.

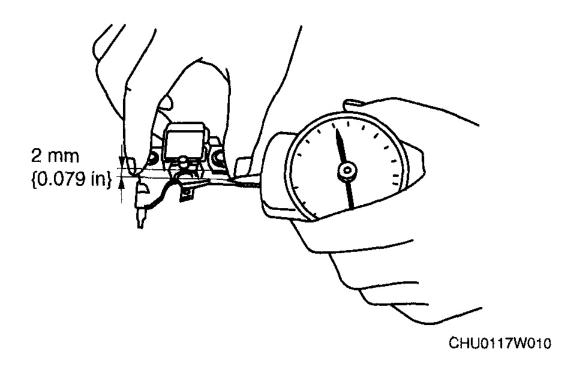
1. Measure the force of the brush spring using a spring pressure gauge.

Fig. 16: Measuring Force Of Brush Spring Using Spring Pressure Gauge Courtesy of MAZDA MOTORS CORP.

- 2. Read the spring pressure gauge at the brush tip projection of 2 mm {0.079 in}.
 - Replace the brush spring if necessary.

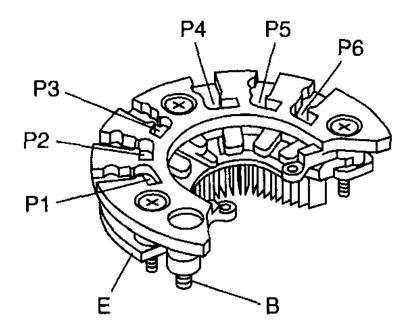
E6U117ZWB007

- 1. Inspect for continuity of the diodes using an analog circuit tester.
 - If not as specified, replace the rectifier.

В	-	No
P1, P2, P3, P4, P5, P6	E	No
-	В	Yes

Fig. 17: Identifying Diodes
Courtesy of MAZDA MOTORS CORP.

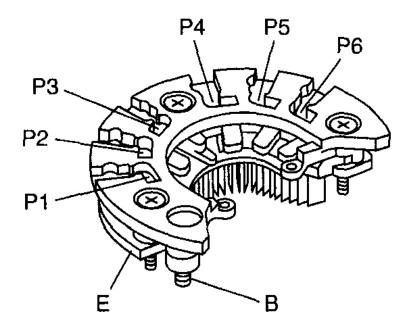
E6U117ZWB007

- 1. Inspect for continuity of the diodes using a digital circuit tester.
 - If not as specified, replace the rectifier.

Negative	Positive	Continuity
E	P1, P2, P3, P4, P5, P6	No
В	-	Yes
P1, P2, P3, P4, P5, P6	Е	Yes
-	В	No

Fig. 18: Identifying Diodes
Courtesy of MAZDA MOTORS CORP.

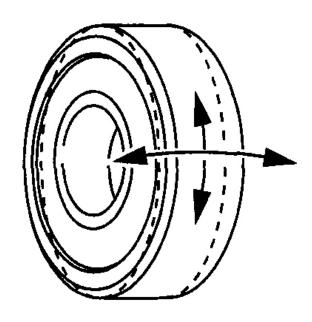
CHU0117W015

- 1. Inspect for abnormal noise, looseness, and sticking.
 - Replace the bearing if necessary.

Fig. 19: Inspecting Bearing Courtesy of MAZDA MOTORS CORP.

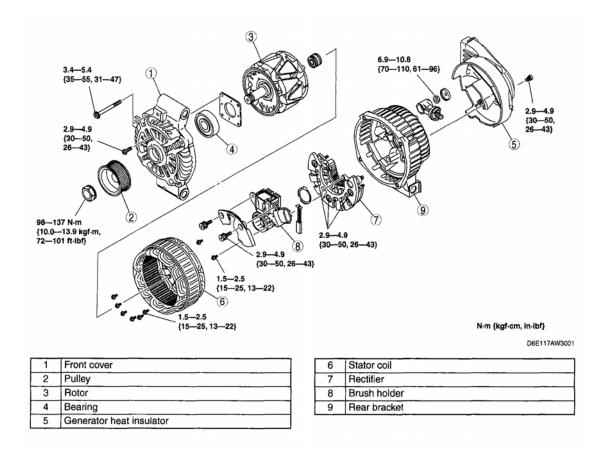
- Melt the solder quickly, otherwise the diodes (rectifier) and regulator will be damaged by excessive heat.
- 1. Disassemble in the order indicated in the table.
- 2. Assemble in the reverse order of disassembly.

<u>Fig. 20: Identifying Disassemble Order Of Generator (With Torque Specifications)</u> Courtesy of MAZDA MOTORS CORP.
