<b>DTC</b>	<b>B0136/74</b>	<b>Open in P/T Squib (LH) Circuit</b>
------------	-----------------	---------------------------------------

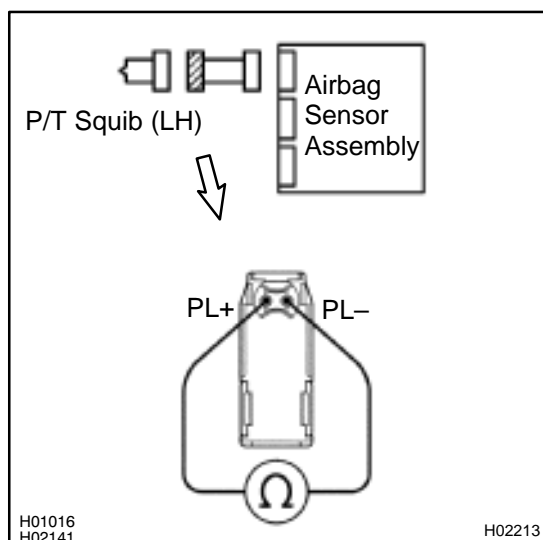
<b>2</b>	<b>Check P/T squib (LH) circuit.</b>
----------	--------------------------------------

For the connector (on the seat belt pretensioner side) between the seat belt pretensioner (LH) and the airbag sensor assembly, measure the resistance between terminals PL+ and PL-.

**Resistance: Below 1 Ω**

**Repair or replace harness or connector between seat belt pretensioner (LH) and airbag sensor assembly.**

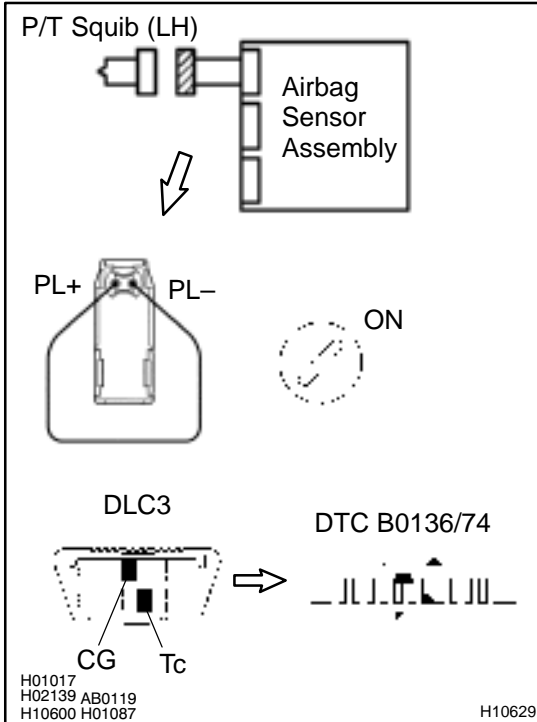
### 3 Check airbag sensor assembly.

- Connect the connector to the airbag sensor assembly.
- Using a service wire, connect terminals PL+ and PL- of the connector (on the seat belt pretensioner side) between the seat belt pretensioner (LH) and the airbag sensor assembly.
- Connect the negative (-) terminal cable to the battery, and wait at least for 2 seconds.

- Turn the ignition switch ON, and wait at least for 20 seconds.
- Clear the DTC stored in memory (See page [DI-237](#)).
- Turn the ignition switch to LOCK, and wait at least for 20 seconds.
- Turn the ignition switch ON, and wait at least for 20 seconds.
- Check the DTC (See page [DI-237](#)).

**DTC B0136/74 is not output.**

**Replace airbag sensor assembly.**

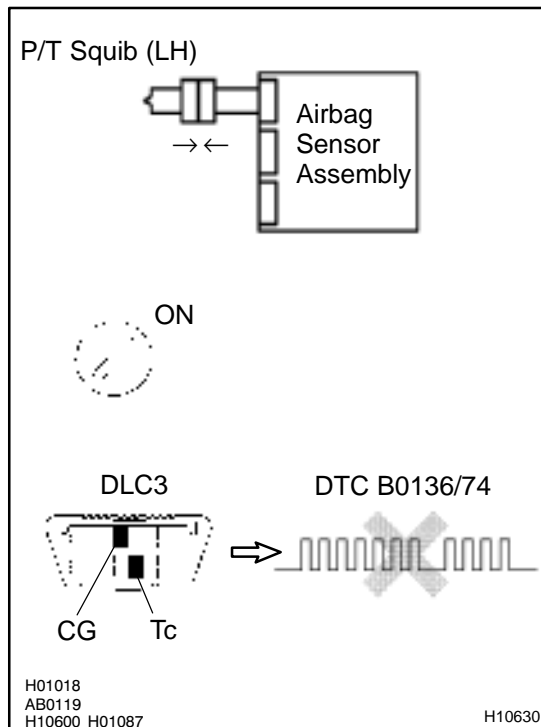
#### 4 Check P/T squib (LH).

- Turn the ignition switch to LOCK.
- Disconnect the negative (–) terminal cable from the battery, and wait at least for 90 seconds.
- Connect the seat belt pretensioner (LH) connector.
- Connect the negative (–) terminal cable to the battery, and wait at least for 2 seconds.

- Turn the ignition switch ON, and wait at least for 20 seconds.
- Clear the DTC stored in memory (See page [DI-237](#)).
- Turn the ignition switch to LOCK, and wait at least for 20 seconds.
- Turn the ignition switch ON, and wait at least for 20 seconds.
- Check the DTC (See page [DI-237](#)).

**DTC B0136/74 is not output.**

**Replace seat belt pretensioner (LH).**
